Assessment and restoration of artificial ponds in the Palatinate Forest

Bewertung und Entwicklung künstlicher Stehgewässer im Biosphärenreservat Pfälzerwald

Wolfgang Frey, Holger Hauptlorenz, Holger Schindler and Gero Koehler

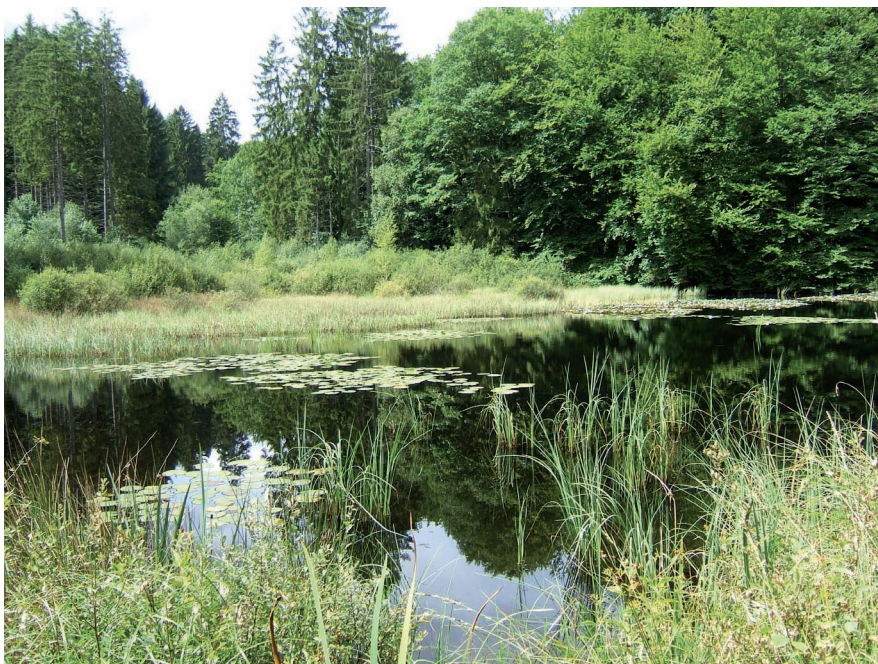
Fig. 1: Secondary biotope with high ecological value at an abandoned pond.

In the Palatinate Forest there are practically no natural bodies of standing water, but there are more than 1,000 artificial ponds (KOEHLER & GRAMBERG 2004). The ponds were originally built for fish or for hydropower, but are increasing being abandoned. Only a few are currently used for fish breeding, recreation, and water sports. In some cases, the related secondary biotopes have developed high ecological value, as shown in Figure 1.

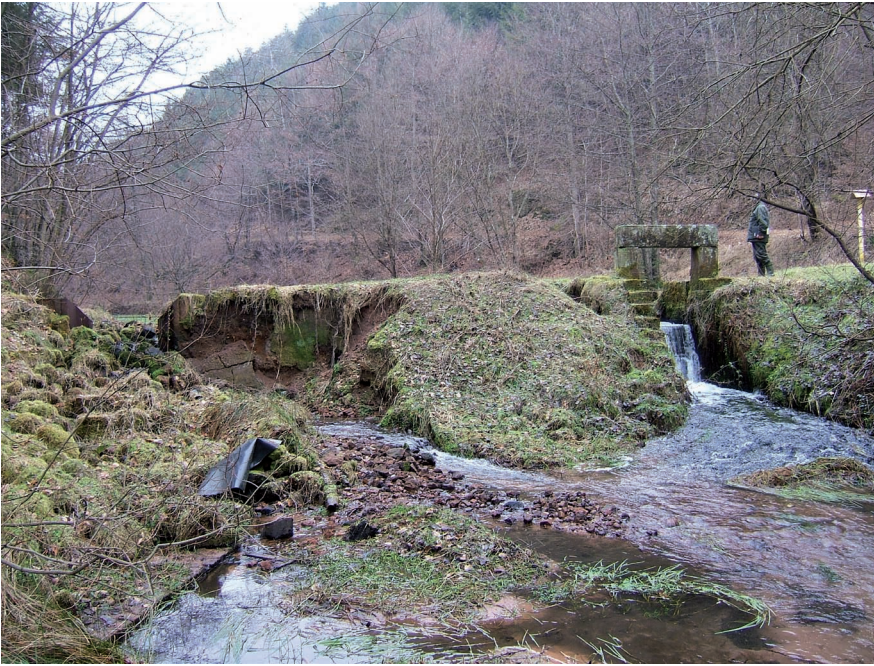
Fig. 9: Drift pond dam from the 19th century with historical outlet structure (right side) and damage requiring restoration (left side).

Abb. 9: Damm eines Triftweihers aus dem 19. Jahrhundert mit erhaltenem historischen Auslassbauwerk (rechts) und sanierungsbedürftigem Schaden (links).

To realize the first measures based on our management concept, we are currently in negotiation with municipalities and forest administration. One anticipated measure, for example, is the rehabilitation of a damaged dam to maintain a historical drift pond with an existing sandstone outlet (Fig. 9). The planning should include the construction of a fish pass to assure the biological passability of the structure.
