Case Report

Management of Retrograde Peri-Implantitis Using an Air-Abrasive Device, Er,Cr:YSGG Laser, and Guided Bone Regeneration

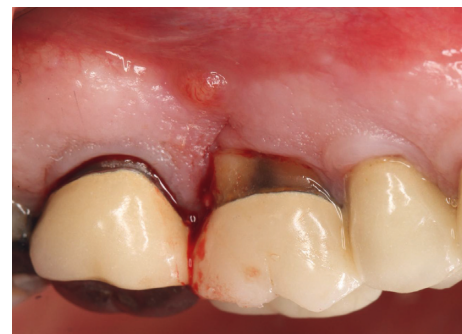
FIGURE 3: Intraoral picture of tooth #3 at the time of tooth extraction. A draining fistula was noted on the distal surface of #3.

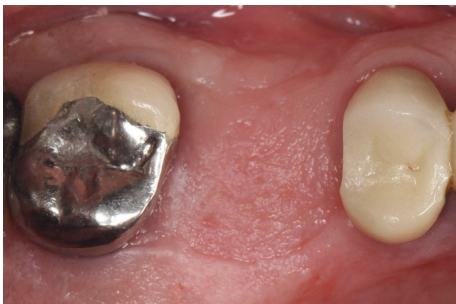
FIGURE 7: The site of #3, 3 months after the ridge preservation showed complete epithelization.

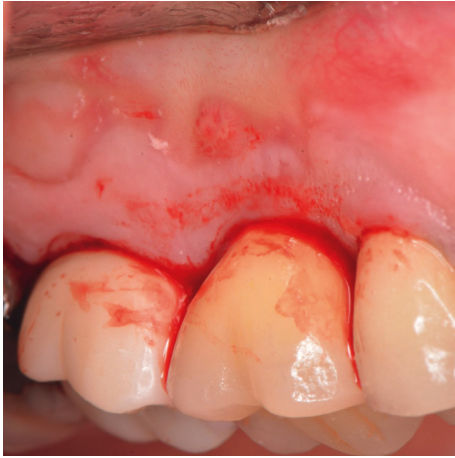
FIGURE 12: The patient presented at the day of surgical debridement of site #3 with a nondraining fistula at the same site where the fistula was noted before the extraction of #3. The picture is taken after the intrasulcular incisions were performed, with the use of a 15c blade.

The patient presented for surgical implant debridement with a nondraining fistula (Figure 12) in July of 2016. The patient understood the benefits and the risks of the surgical approach and signed a consent form. The site #3 implant showed ~5.5 mm lack of radiographic bone density around the apex (Figure 13). The site was anesthetized by means of local infiltrations, on the buccal and palatal aspects of tooth #3. Intrasulcular incisions extending from #2–4 were performed with a vertical releasing incision placed at the mesial line angle of #4. Upon reflection of a full thickness flap, a fenestration of 2×2 mm and 7 mm depth was revealed around the apex of implant #3 (Figure 14). Fibrous granulation tissue was present on the mesial, palatal, and distal aspects of the implant. The bone defect was degranulated using Gracey curettes. No communication with the maxillary sinus was found. The implant surface was initially decontaminated utilizing an air-abrasive device with amino acid glycine powder avoiding direct contact with the implant surface and copious amounts of sterile saline to remove the powder from the implant surface and bone defect (Figure 15). After degranulation, seven threads of the implant were exposed (Figure 16). Before the first laser pass, the patient and the operating staff wore special protective glasses according to U.S. Food and Drug Administration rules [19]. Implant surface decontamination continued utilizing Er,Cr:YSGG laser (with a wavelength of 2,780 nm) at 1.5 W/25 Hz and a radially firing fiber tip (500 μm, RFPT5-14 mm, Biolase Technology, Irvine, CA) (Figure 17). The laser tip was placed perpendicular to the implant surface and 5 mm away from the implant surface. The area was irrigated with saline, and the sequence was repeated (air-abrasive device, sterile saline irrigation, and Er,Cr:YSGG application). Each laser irradiation occurred approximately for 2 minutes. Cortical perforations

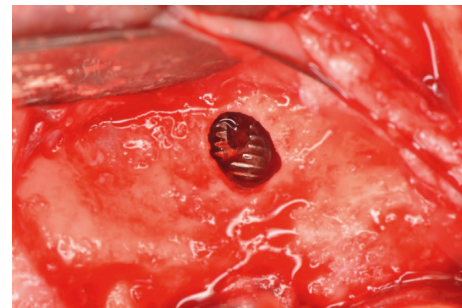
FIGURE 17: Exposed 7 threads of the implant.

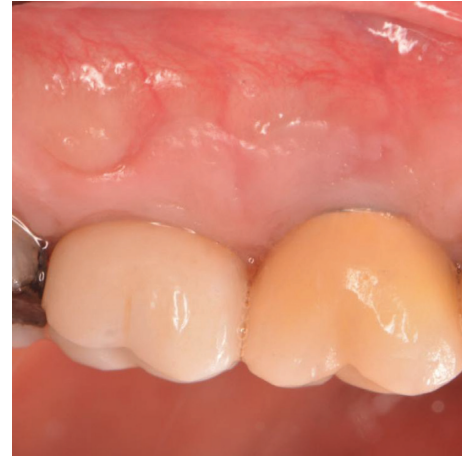
FIGURE 22: Clinical evaluation 13 months postoperatively showed no signs of pathology.

nonabsorbable monofilament sutures. The patient was prescribed amoxicillin 500 mg three times daily for a week, codeine/acetaminophen 30 mg/300 mg every 6 hours as needed for pain management, and a 0.12% chlorhexidine oral rinse twice daily. The postoperative protocol was very strict with biweekly appointments, until the suture removal in 4 weeks. After the initial phase of healing, the patient returned monthly, for the next 12 months in the clinic, for clinical evaluation of the surgical site and radiographic evaluation. The patient healed uneventfully, without any signs of infection or inflammation. Postoperative periapical radiographs from 6 to 13 months showed the increased density of the bone around the implant apex (Figures 20 and 21). The intraoral picture, 13 months postoperatively, displayed no signs of pathology and the probing depths around the implant measured ≤ 4 mm (Figure 22).
