## The Wells, Subterranean Passage, Tunnels and Water Systems of Hagia Sophia in Istanbul

Çiğdem Özkan-Aygün

### Summary

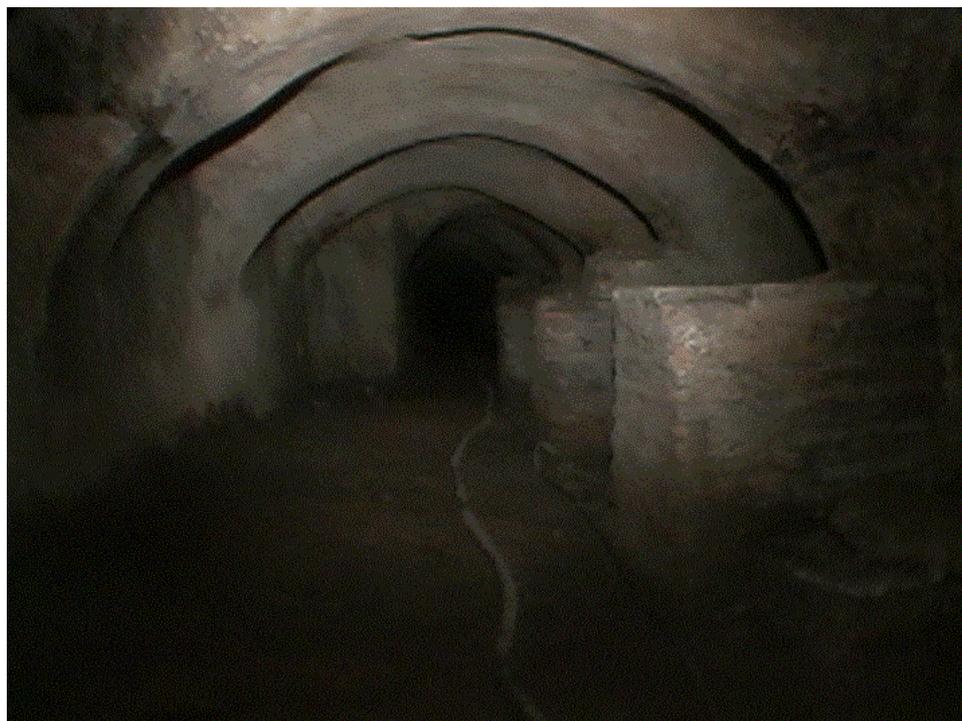
Fig. 1. The vaulted passage under the inner narthex

supported on 23 brick pillars. The pillars, on the northern side, filled in with bricks at a later date, measure 60x60 cm (fig. 1). The height of the vaults is 1.4 m at the highest point of the arch. The floor, walls and pillars are covered with a thin layer of mortar and are painted a yellowish color. It is possible to see the watermark on the mortar layer and Erdem Yücel, the former director of the Hagia Sophia Museum, informed the team that when the vaulted passage became filled with water it had to be emptied with pumps and the drains cleaned.

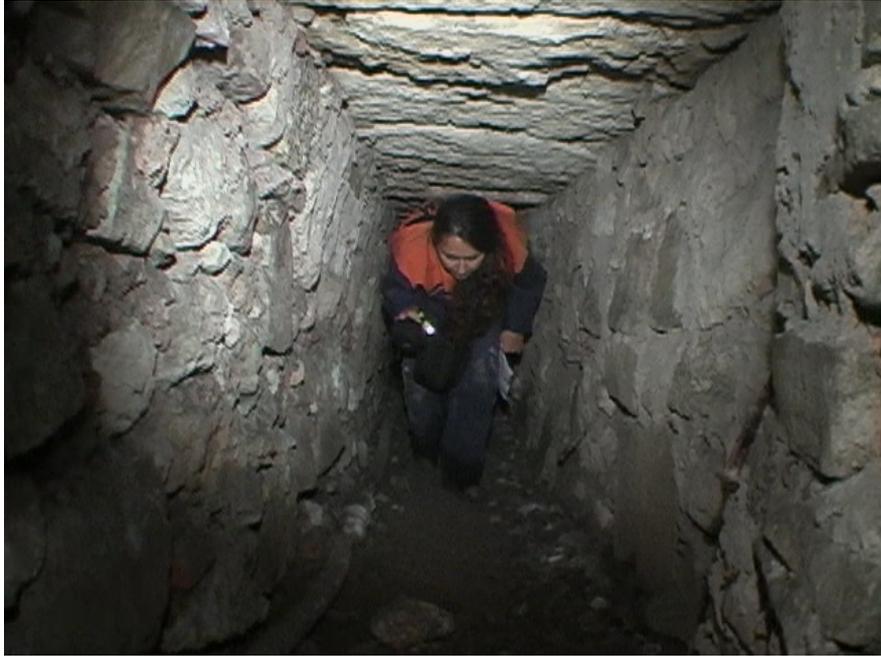
Fig. 2. The tunnels connected to the vaulted passage

The vaulted passage connects with narrower tunnels (fig. 2) from the north and south, which, at places, have heights of 50 cm. Another tunnel branch turns towards the west and then runs parallel to the outer narthex. At the northern end of that tunnel, there is visible a water pipe that seems to head towards the atrium but it is blocked with a wall (fig. 3). Two additional branches go towards the marble urns transferred from Bergama in the Ottoman period. Water overflow from the marble urns is drained away by small channels into a subterranean tunnel via a small hole at the base of each urn. There also is a possible connection of that branch of the tunnel with the well that is closest to the urn at the southwest of the building. Initially, the tunnels may have been built to allow the escape of moisture, thus avoiding an increase of humidity, and to provide ventilation as the architect Mimar Sinan applied similar technology in 16th century mosques. As a result, since some tunnels have been blocked up, humidity has become a problem in the building.

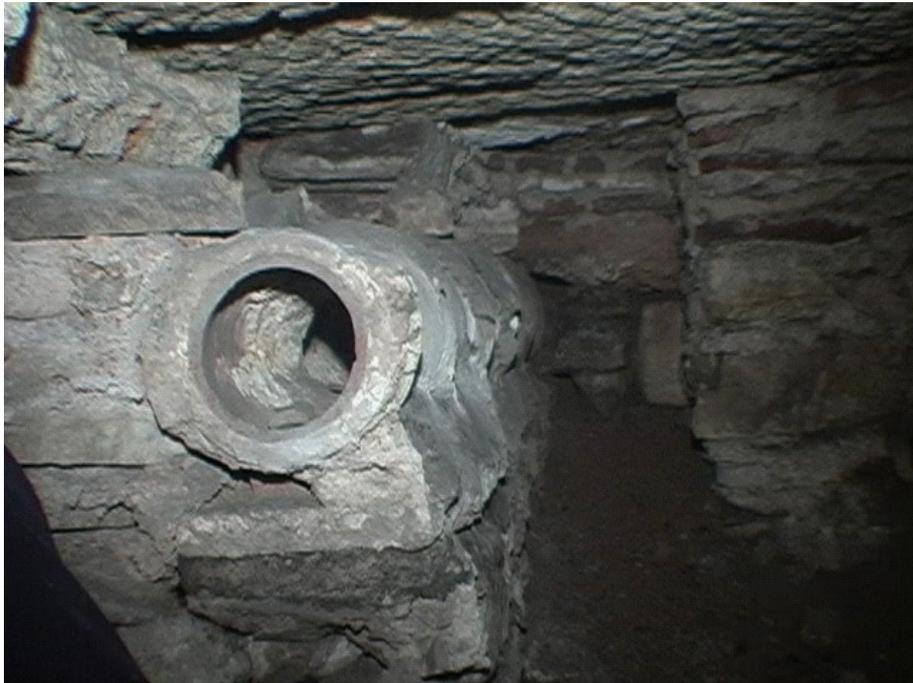
Fig. 3. The water pipe that seems to head towards the atrium

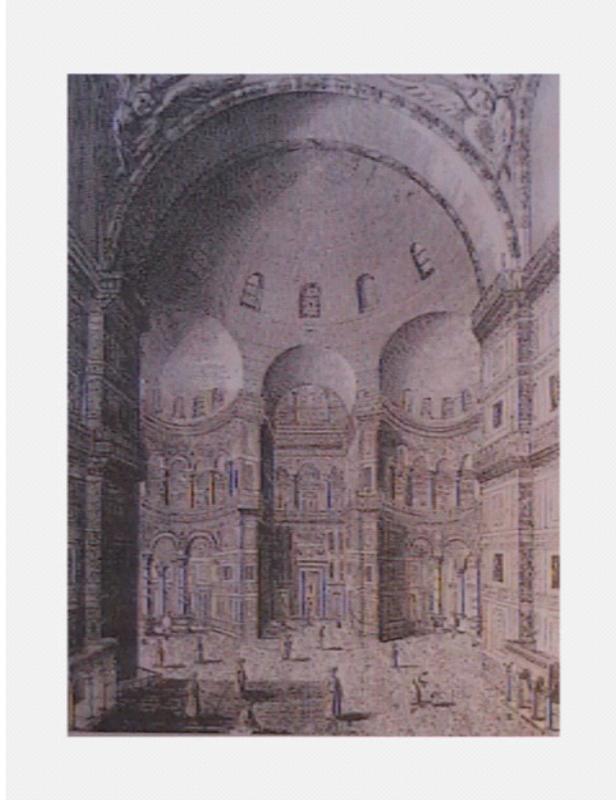
Fig. 4. Grelot 1683, Ottoman pulling water from the well no.1

The project has identified nine wells from the Byzantine and Ottoman periods inside the building and the gardens of the Hagia Sophia, five of which still hold water. Two of the wells in the building were explored with underwater diving methods. The first well surveyed was situated at the northwest of the nave and was discussed initially by Grelot, and the second well opens into the grand cistern under Hagia Sophia (fig. 4).<sup>3</sup>

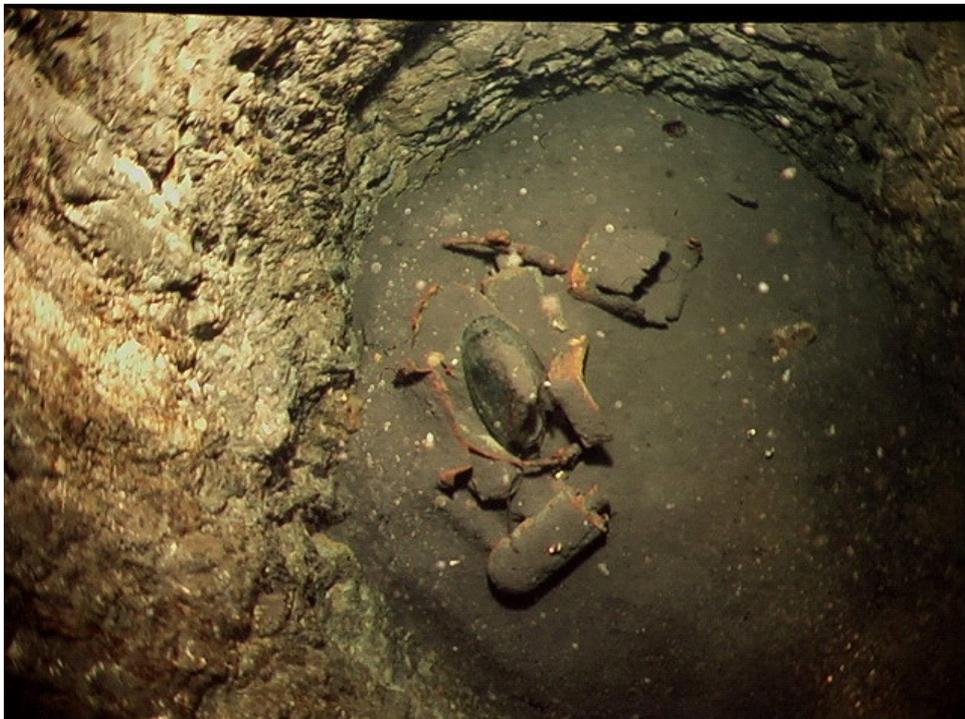
Fig. 5. The metal canteens and glass flask from the well which was filled with 10 m of water on the north west of the nave

Despite the almost 100 years gap, the difference between the 2005 November measurement and the 1904 measurement is only 0.1 m. The survey recorded a metal WWI canteen, a glass flask, and the remains of a glass lamp in the mud (fig. 5). The true depth of the well (to the base of the mud) will be measured by geophysical methods. The walls of the well, from the well mouth to 2.38 m below the floor, are constructed of irregular pieces of brick and marble joined with mortar. The remaining length of the well-shaft was dug from the bedrock on which Hagia Sophia stands. As a result, the walls are covered in rock dust, which creates low visibility for diving, thus, suggesting that the water from the well may not have been used for human consumption.

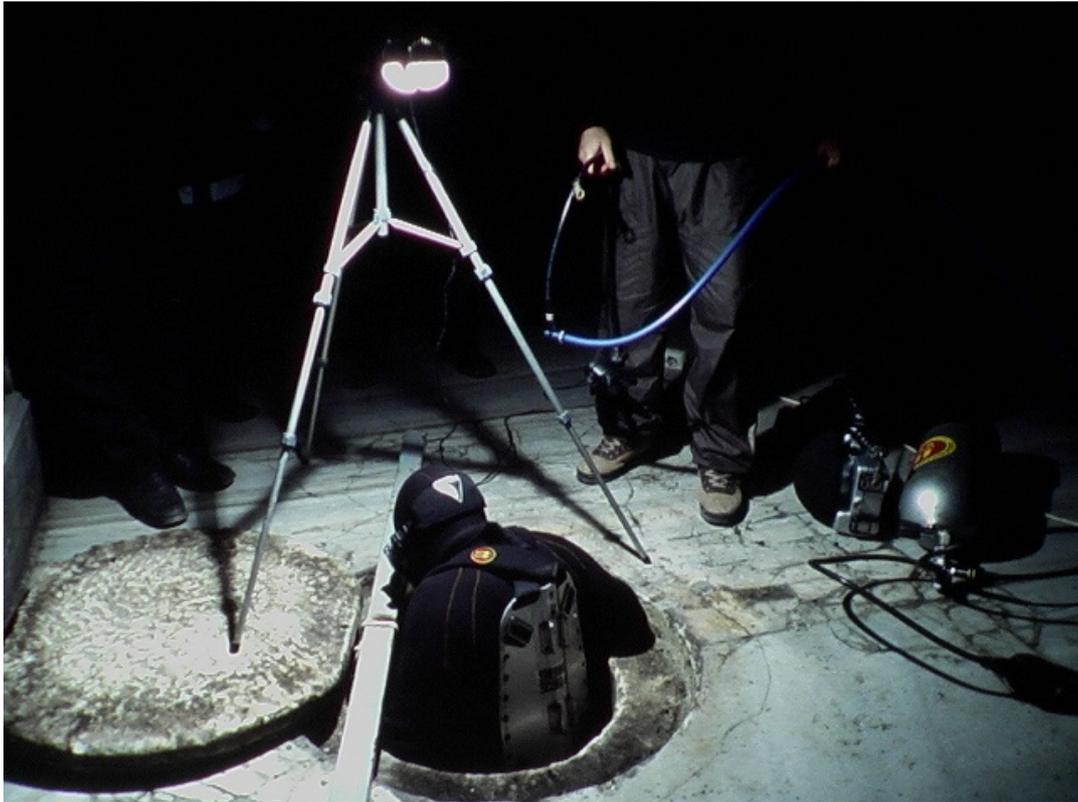
Fig. 6. The hookah system to dive in the well on the southwest of the nave

The second explored well is located in the southwest of the building close to the Ottoman marble urn. The depth of the well from the well-mouth to the bottom is 8.8 m with a water level of 6.5 m. It is paved with travertine stones that are cut to fit the shape of the well (fig. 6) and, thus, the water is very clear because of the smooth and clean surface.
